Slope stabilisation at Furama Riverfront Hotel

Case Study

| Project: | Slope stabilisation at Furama Riverfront Hotel |
| Material: | Geotextile GeoBags |

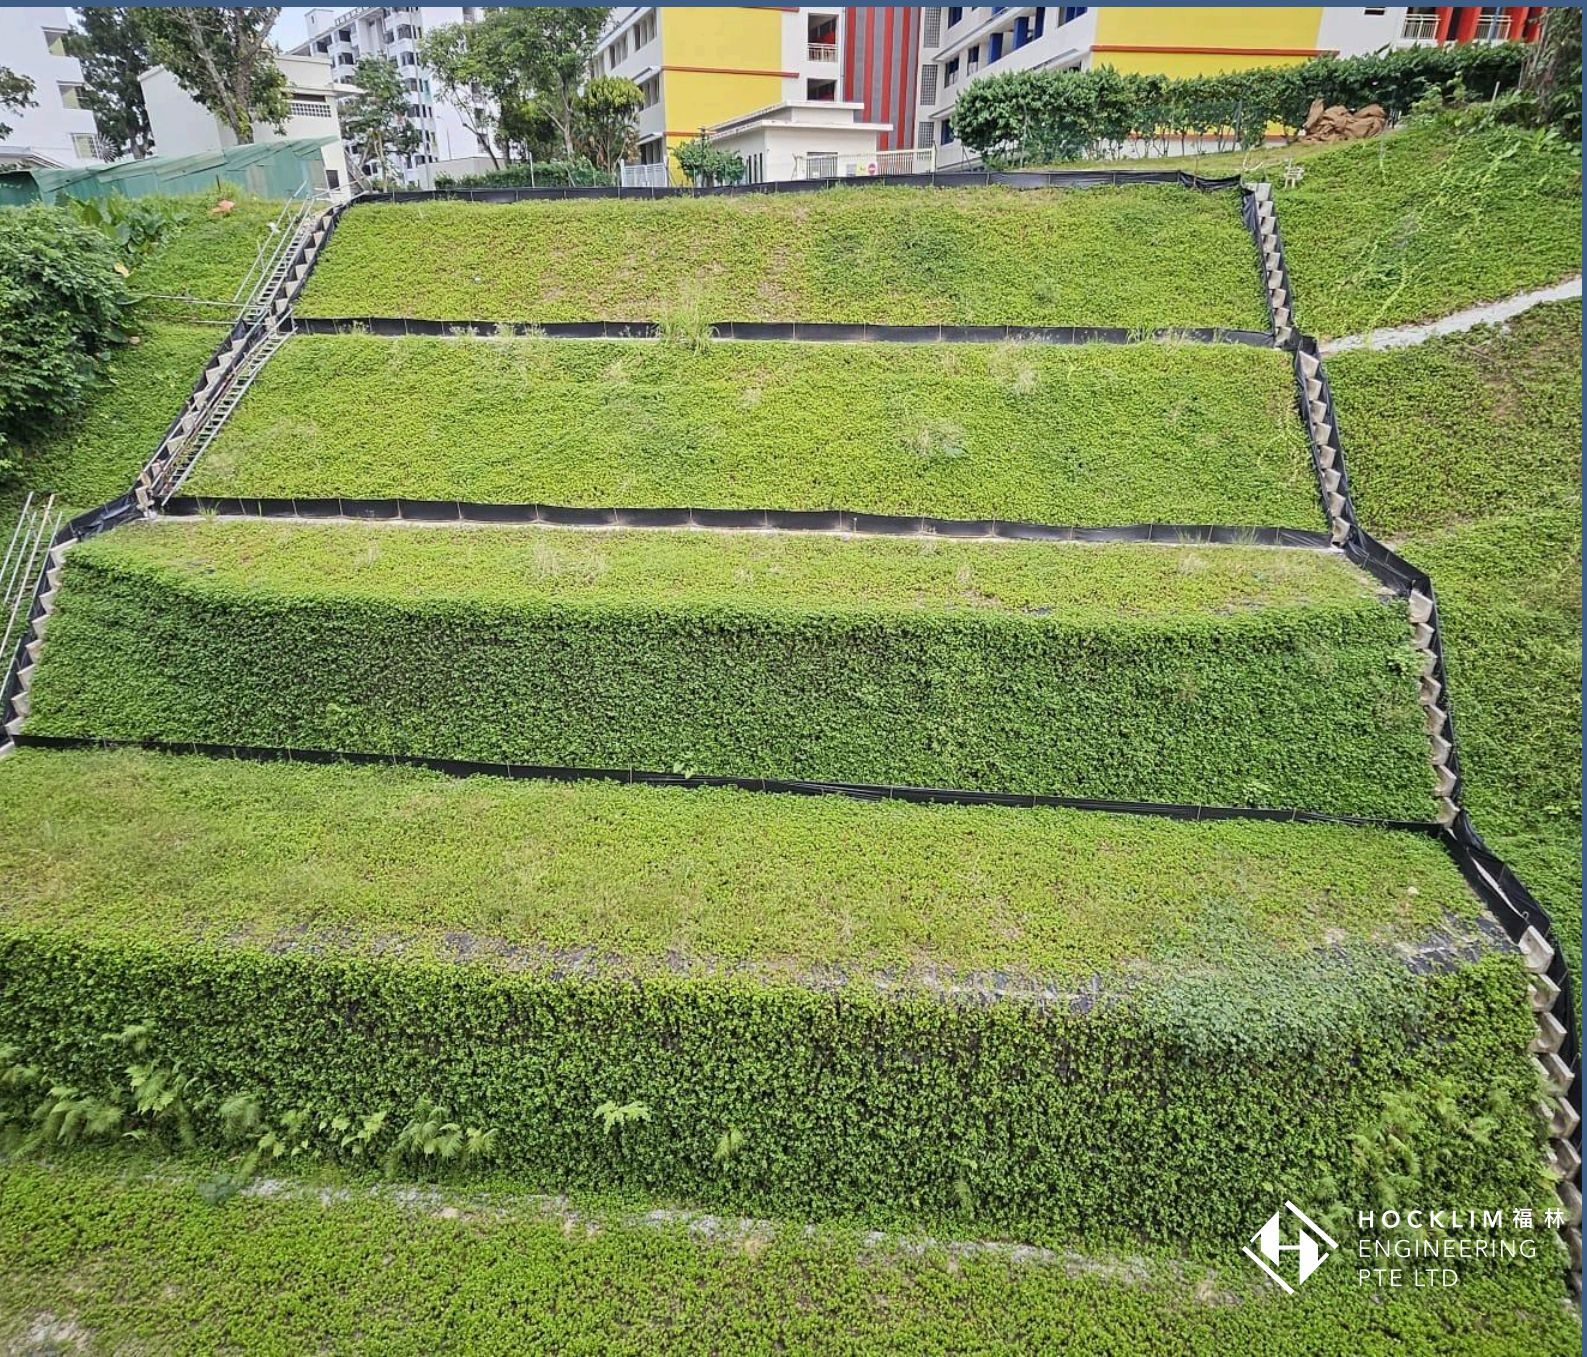
During the monsoon season, Singapore has seen unprecedented levels of heavy rain and flash flood, leading to a landslide on a slope that connected Outram Secondary School to the Furama Riverfront Hotel, located near Jalan Minyak and York Hill. The landslide occurred on a section of the slope that has been stripped of any vegetation foliage.

Figure 1: Landslip occurrence near Jalan Minyak and York Hill

To repair the collapsed slope and prevent further occurrence of landslip in that area, installing the GeoBarrier system for soil stabilisation to the section of the slope prone to landslip was the solution. This environmental solution was introduced and has been used by Hocklim since 2020 for soil slope stabilisation. However there were a few difficulties with installing the single terrace GeoBarrier system on the existing slope. As the existing slope has a height of 22 metres, utilising the GeoBarrier system with a single terrace would not allow the efficiency of dispersing the sub soil water due to a high concentration of sub soil water in the slope.

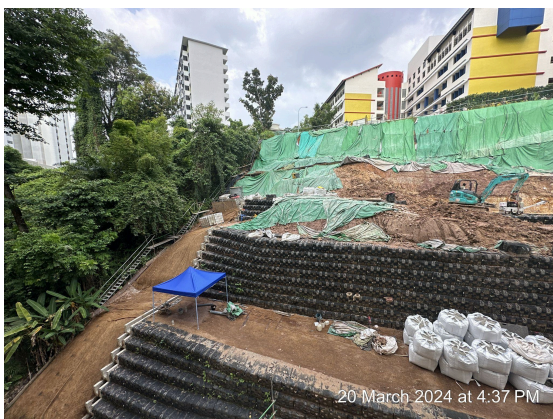
Figure 2: Layers of Geobags installed in the multi terrace GeoBarrier system.

With the difficulties of installing the single terrace GeoBarrier system on the existing slope, extensive planning to design a customised GeoBarrier system utilising a multi terrace platform concept was born. This is the first multiple terrace platform concept to be introduced globally. In order to mitigate the requirement of long geogrid, i.e. around 15.4m length, the ground lock system was introduced for the project to protect the Geobarrier system from any soil erosion during heavy rainfall.

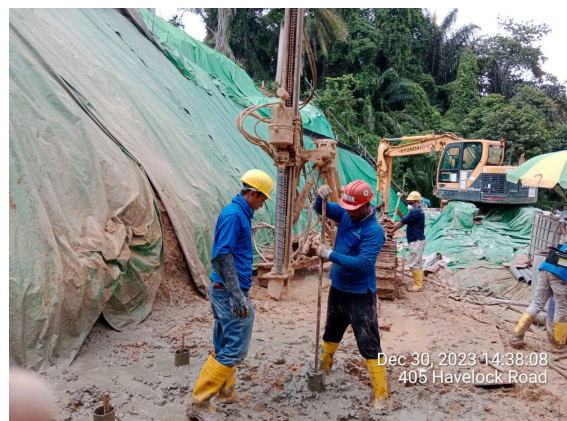
Figure 3: Installing the ground lock system

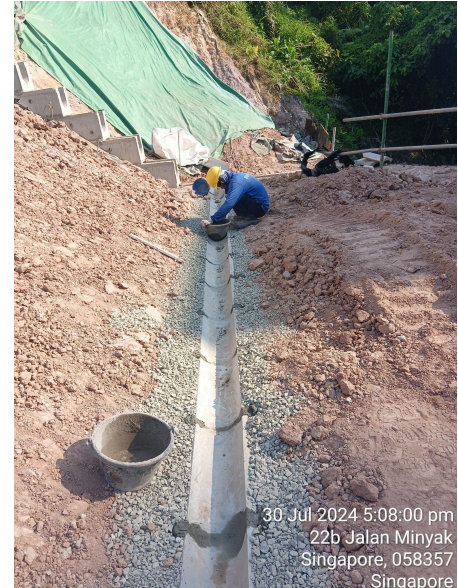
Figure 4: Constructing the surface run off drains at the toe of the terrace.

The current multi terrace GeoBarrier system design used at York Hill comprises of 5 terraces. These terraces serves many purposes. Firstly, each terrace consists of a surface runoff and sub soil drain at the toe of the terrace. The 5 drains greatly increase the efficiency of dispersing the sub soil water and surface runoff water to prevent the building up of a high concentration of sub soil water in the slope.

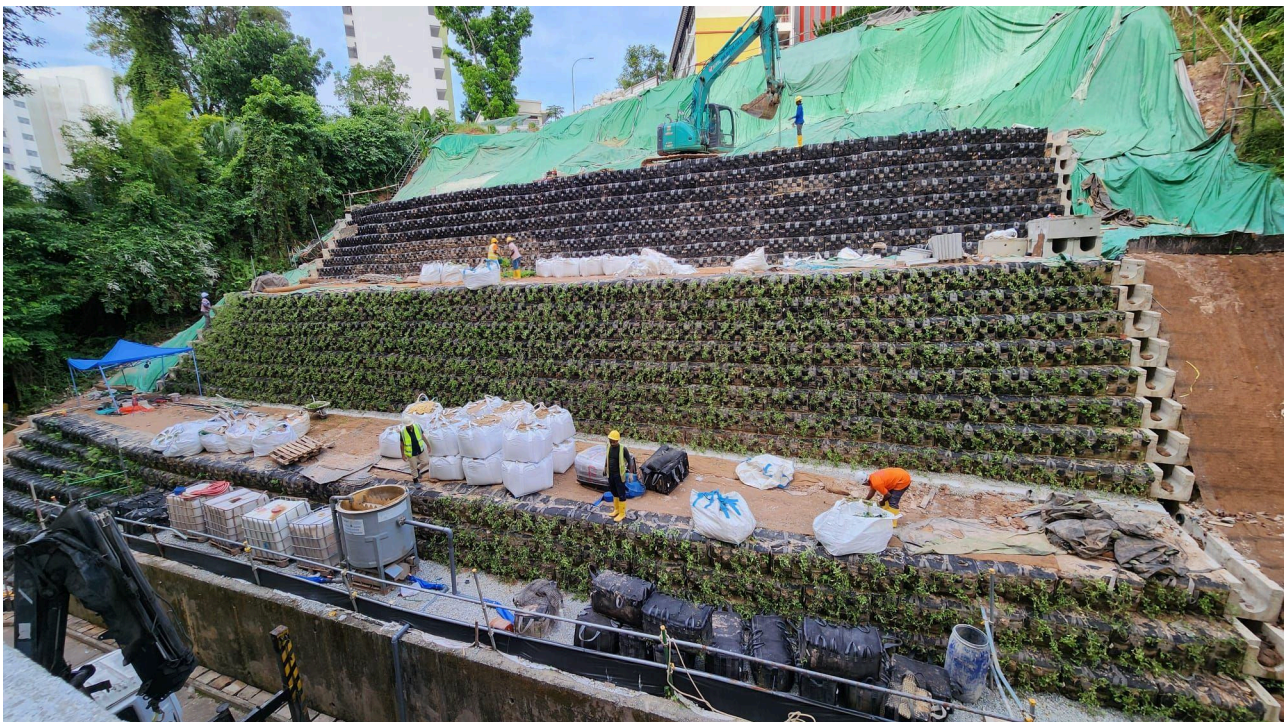
Figure 5: Utilising the working platforms to store materials and access for machinery.

Secondly, each terrace has a berm where it serves as a working platform during the construction of the next terrace to store materials and access for machinery.

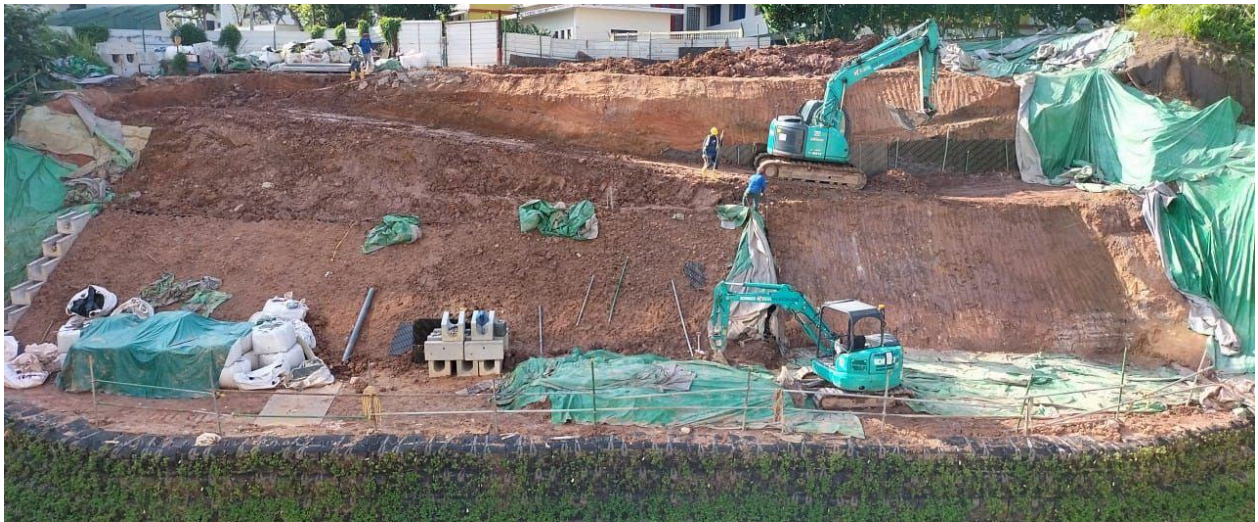
Figure 6: Excavators delivering materials from the crest of the slope to the respective working platforms

Hocklim had to find alternative ways to run our operations more efficiently to meet the timeline. One way was to create another site access point by accessing the back of the site at the crest of the slope on Jalan Minyak. By utilising the multi terrace working platforms, Hocklim was able to deliver materials from the crest of the slope to their respective terrace for storage.
